SLIPPERY ROCK WATERSHED COALITION

ERICO BRIDGE RESTORATION AREA

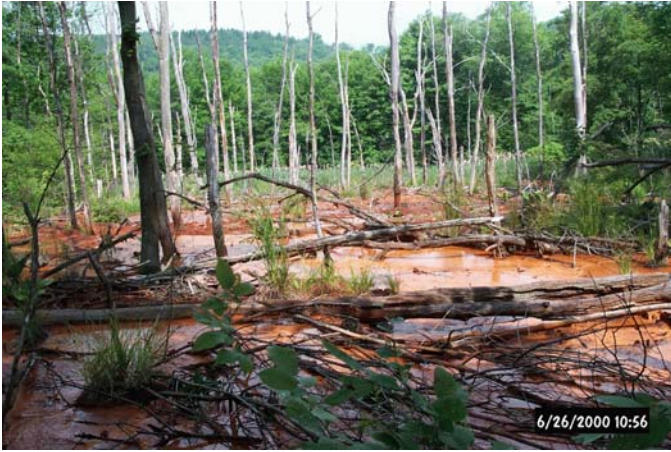
[Portion of "kill area" below abandoned mine drainage]

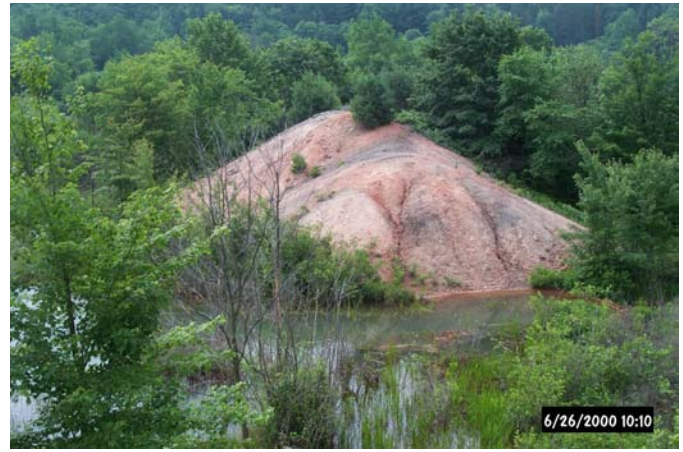
[Portion of 60,00-CY of abandoned coal refuse in Seaton Creek]
